## *Imagery Analysis Report*

New Shipyard Under Construction

Kuang-chou, China

DDI/IAR 83023

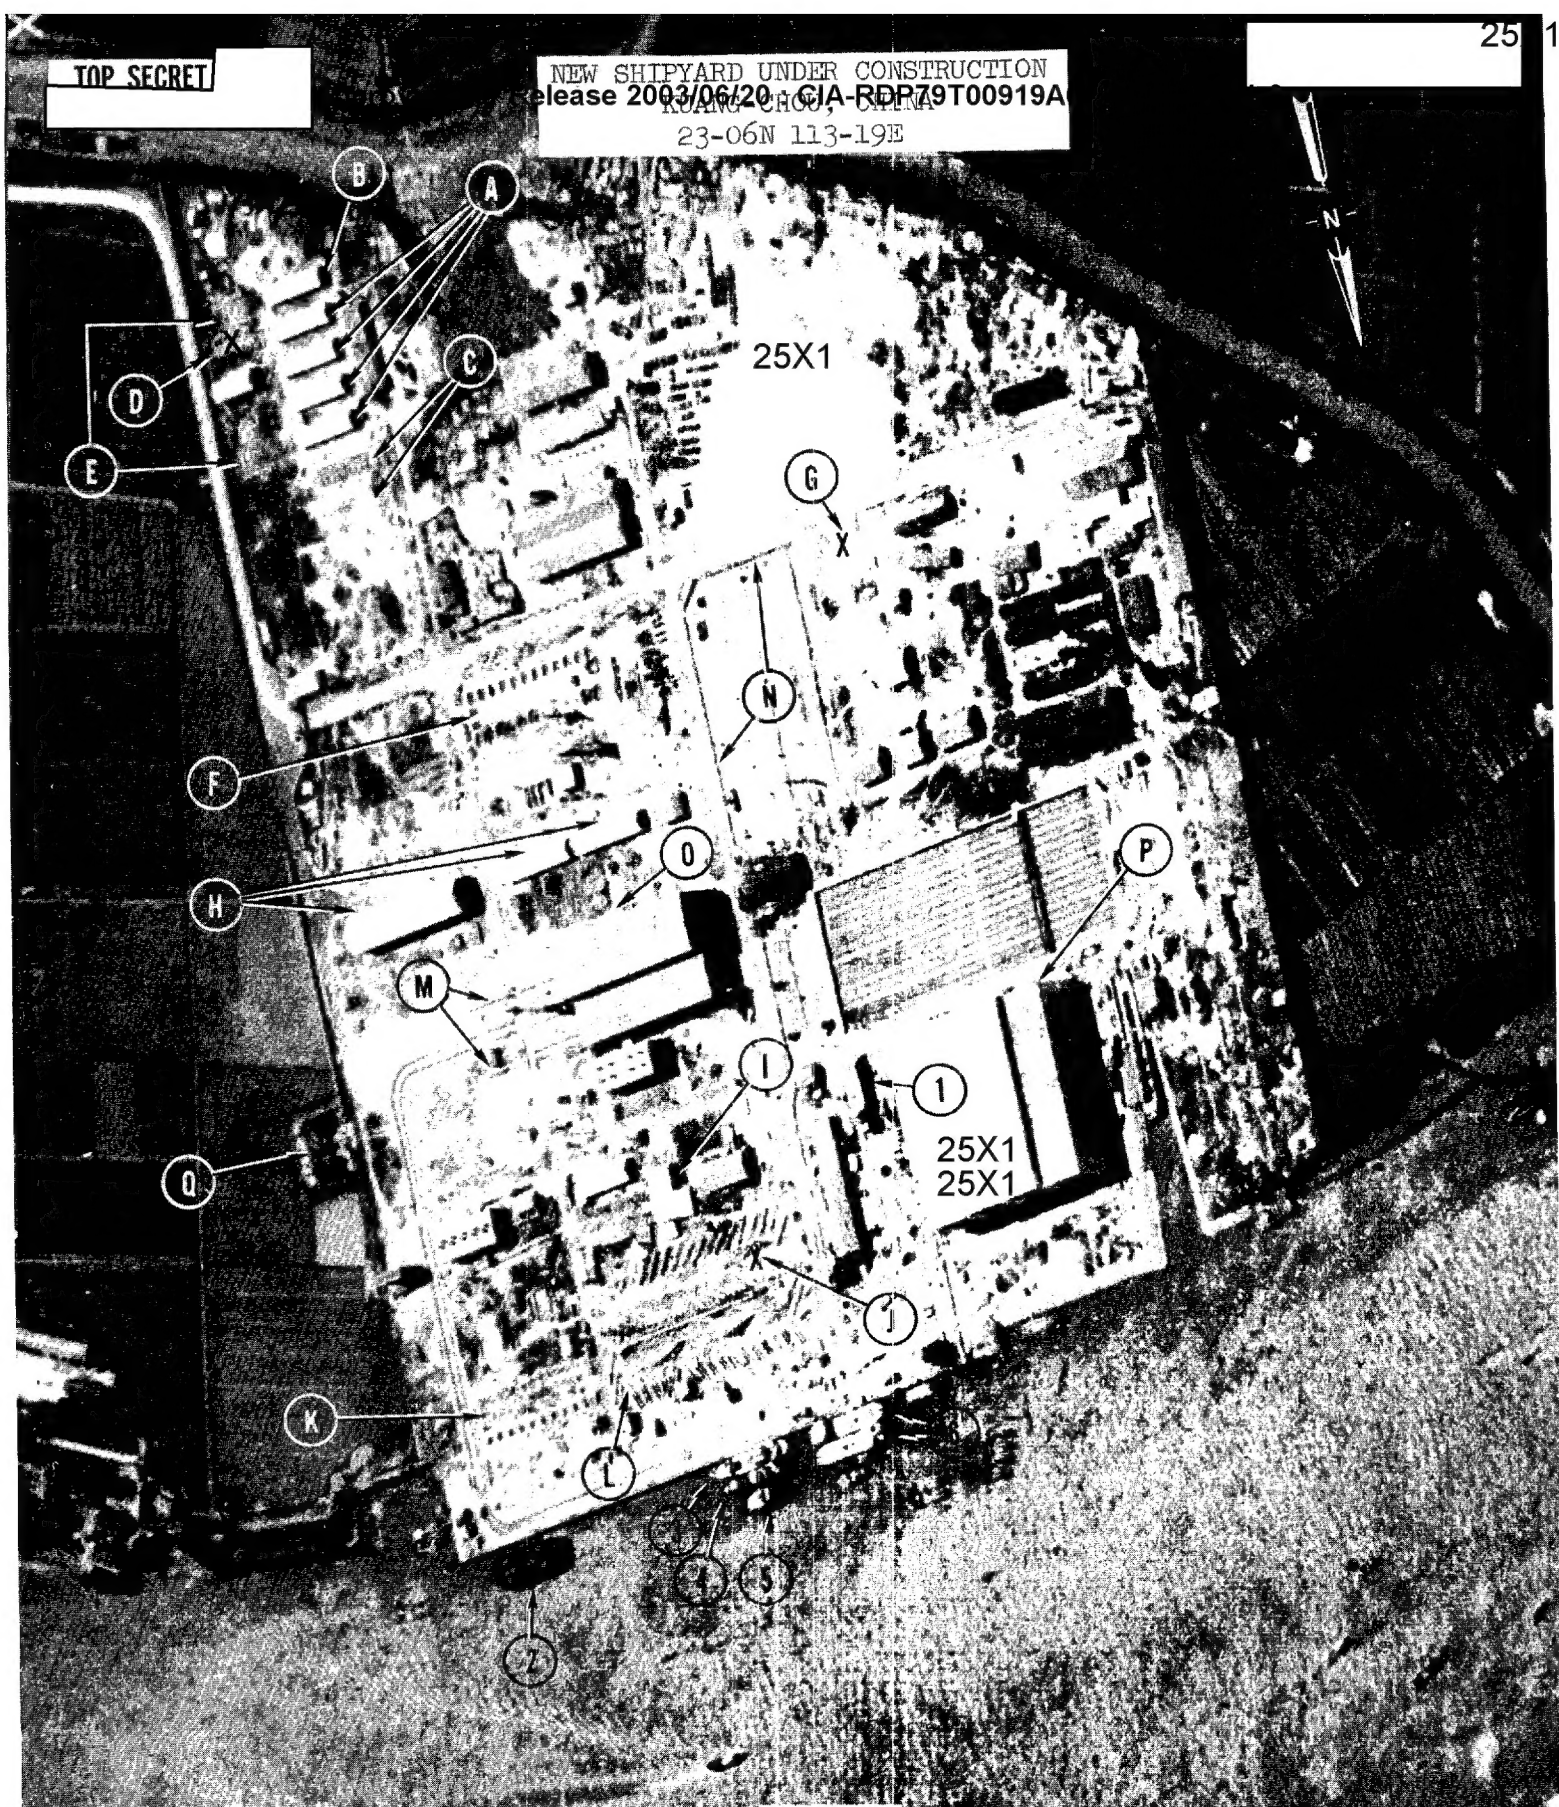
#### KEY TO VESSEL ANNOTATIONS ON FIGURE 1

1. Unidentified vessel under construction on building way (LOA approx 90' \*). The superstructure aft, the squared-off bow and stern and the overall appearance indicates that this vessel is possibly an amphibious design.

2. Unidentified vessel (LOA approx 135'). A rounded stern and a pointed bow, plus an unusually wide beam, give an appearance similar to a ferry.
3. Unidentified probable trawler (LOA approx 125'). This vessel has the overall topside detail, hull shape and characteristic of an AKL; however no armament is discernible.

4. Unidentified probable trawler (LOA approx 115'). Identification is based on hull shape and topside detail.
5. Unidentified vessel (LOA approx 85'). Overall appearance indicates vessel is a possible ATA/YT.

6. Two probable river barges (LOA approx 120'). Identification is based on the relatively clean deck, with superstructure aft, and the rounded appearance of the bow.

#### KEY TO FACILITY ANNOTATIONS

- A. Four new buildings (LOA each building approx 95 by 30'). These buildings have been completed. See Annotation A, Figure 1.
- B. New building (LOA approx 95 by 30'). An additional building of the same design and measurements as those at Annotation A above, has also been built. Although not annotated, foundation preparations for this building are discernible at the southern end of the above referenced buildings.

- C. New building construction.  
Foundation preparations for a sixth and possible seventh building of the same design seen at Annotations A and B above are now underway.

- D. Small building seen on last readout has now been removed.
- E. New probable building construction.  
Several probable building foundations can be seen under construction. Construction on these foundations was begun [REDACTED]

- F. New building under construction.  
Vertical supports and other building materials surround the probable perimeter of the site of a new building to be constructed.

- G. Small building seen at this location on last readout has now been removed.
- H. Three buildings seen under construction at facility Annotation B in the last readout, all appear to be structurally complete.

- I. New building under construction since last readout.
- J. Small building seen on last readout has now been removed.
- K. Vertical supports and other building materials surround an area probably intended for the construction of a new building. Foundation work appears to be under way.

- L. New building construction.  
Construction activity in this area indicates that a large building is going to be constructed. Foundation preparations appear to be underway, several probable storage/supply sheds can be seen, and two cantilever-type cranes are in the area. Vertical supports and other building materials have also been laid out.

- M. Crane rails under construction.  
A set of crane rails is being installed on either side of the existing craneway tracks. The ultimate direction of these new rails cannot be determined, since the construction thus far stops about halfway between the suspect fabrication building and the point where the existing crane-way turns northward toward the fitting-out quay.

- N. Probable security screens.  
Security precautions now appear to be going into effect around the building ways on both sides of the transverser, as evidenced by imagery probably equating to security screens.
- O. Possible fabrication building (approx dimensions 235 by 120').
- P. Four-bay construction hall (LOA dimensions 270 by 240').
- Q. Earth covered bunker with two entrances.  
Unidentified activity is continuing at the earth covered bunker. See Annotation G, Figure 1.

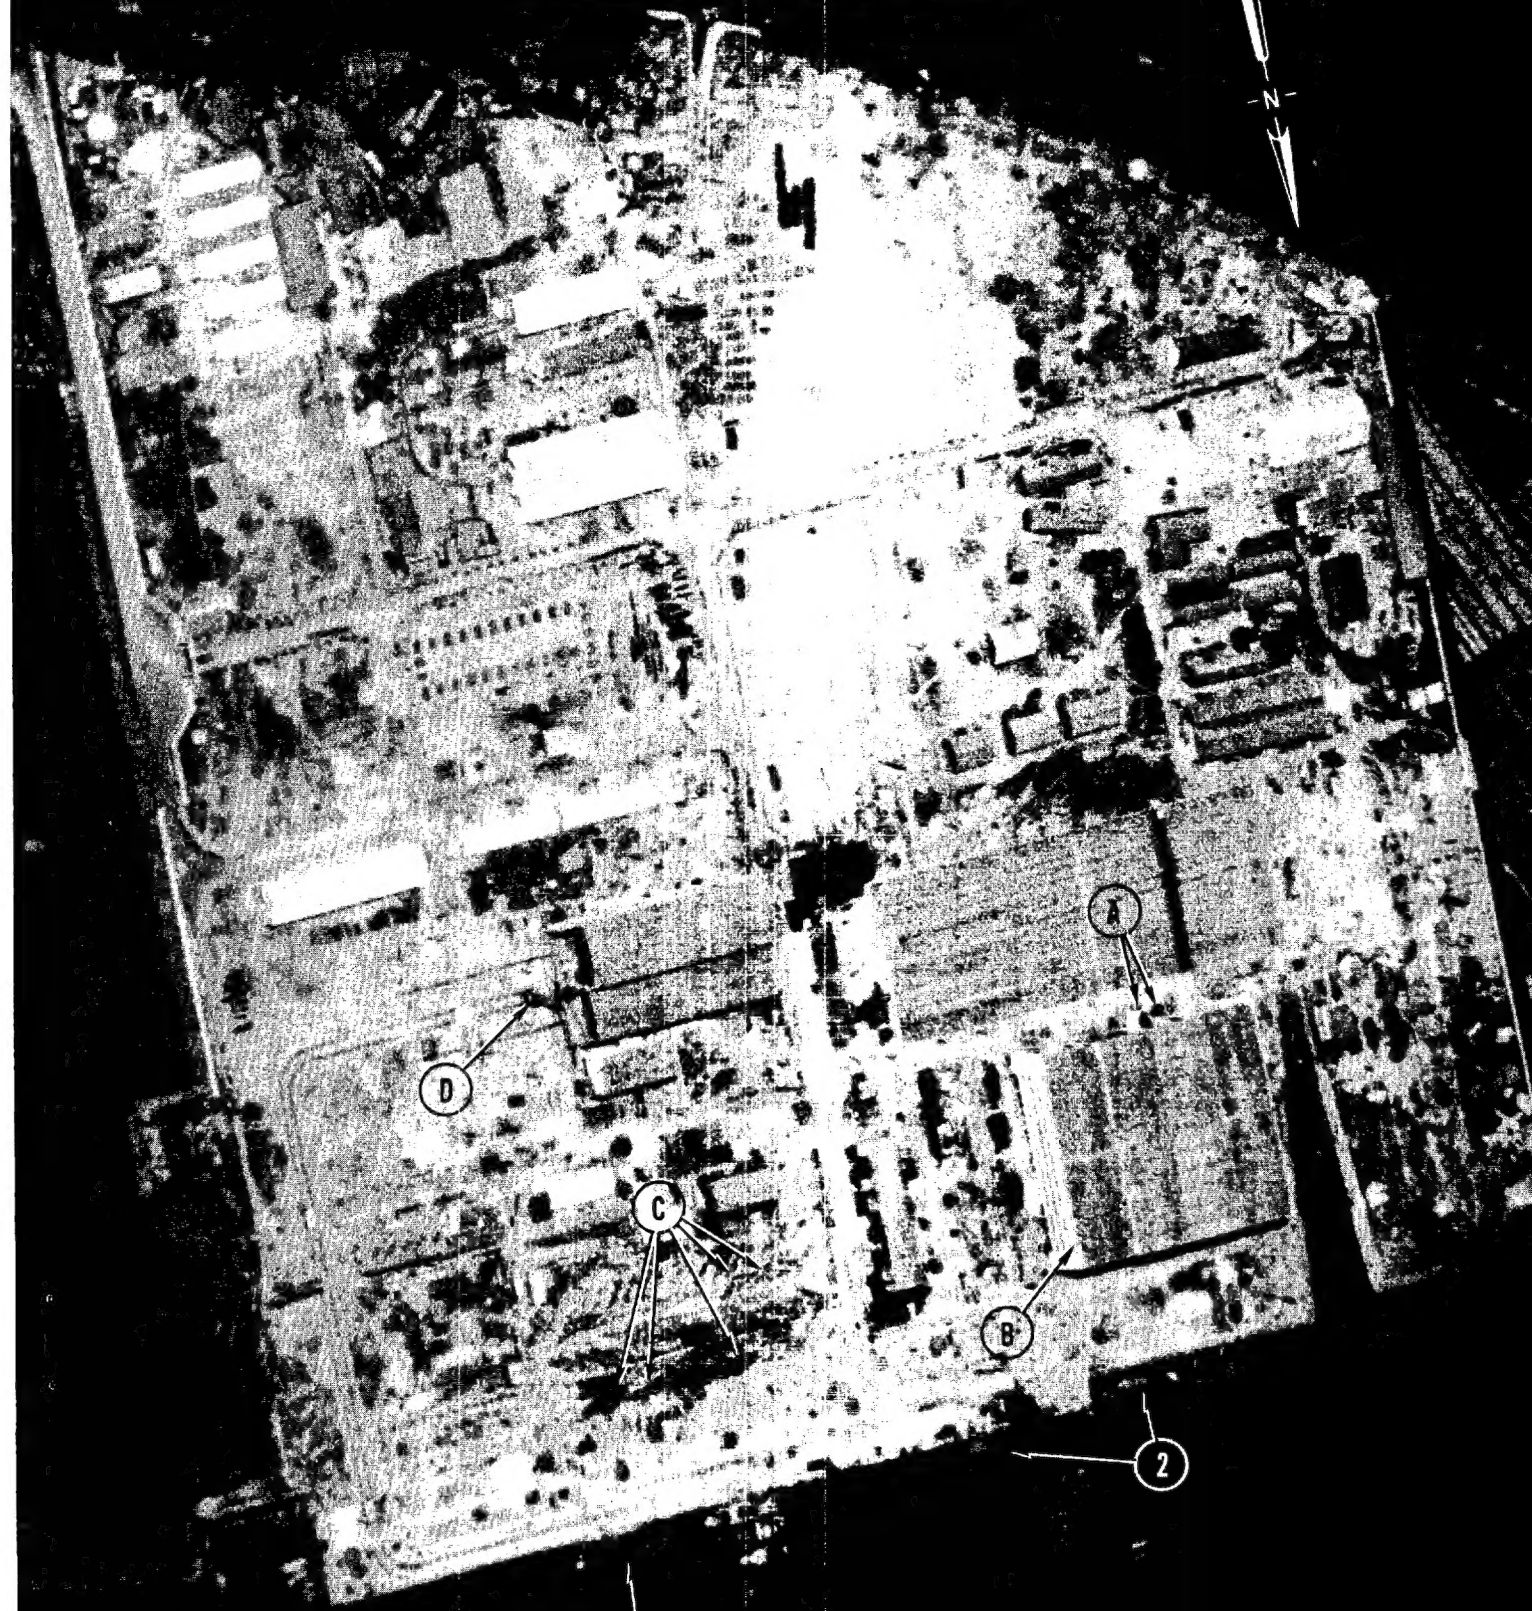
KEY TO VESSEL ANNOTATIONS ON FIGURE 2

1. Unidentified vessel (LOA approx 160').  
Visible features indicate vessel is possibly a merchant ship.
2. Two unidentified vessels alongside quay (LOA of each approx 65').

NOTE: Vessels annotated on this coverage [redacted] were not seen or  
previously identified on the [redacted] coverage.

KEY TO FACILITY ANNOTATIONS

- A. Suspect vessel imagery.  
Two possible vessel bows can be seen protruding from the south end of the four-bay construction hall.
- B. Construction hall.  
The four-bay construction hall is probably constructed of reinforced concrete and trussed arches, and each bay is possibly equipped with an overhead crane. (See Annotation G, Figure 1, [redacted])
- C. Prefabricated roof trusses.  
At least five prefabricated roof trusses can be seen among the material laid out for the construction of a new building. (See Annotation L, Figure 1, of this report.)
- D. Rail crane (type is unidentified).
